**VerdErg VETT Fish Testing Programme - 3rd  
Party Accreditation of Test on fish  
survivability of prototype VETT venturi**

Dr Billy Sinclair

Centre for Wildlife Conservation  
University of Cumbria  
Newton Rigg  
Penrith  
Cumbria CA11 0AH

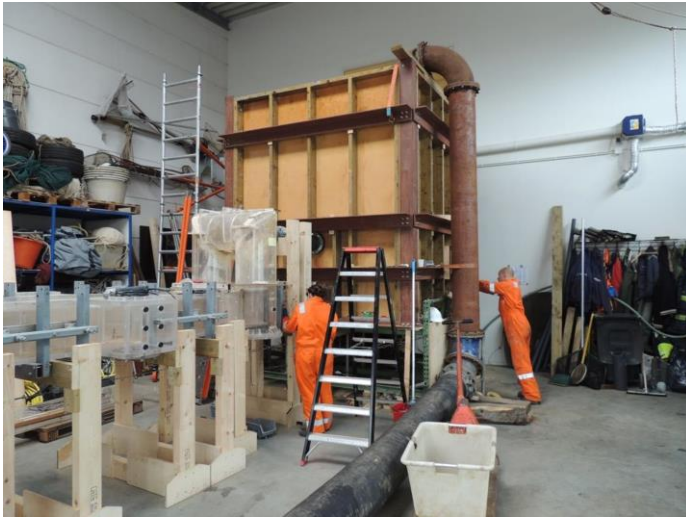
**Fig 2a:** The 3m Header tank with associated water inlet pipe and connection to the VETT device.

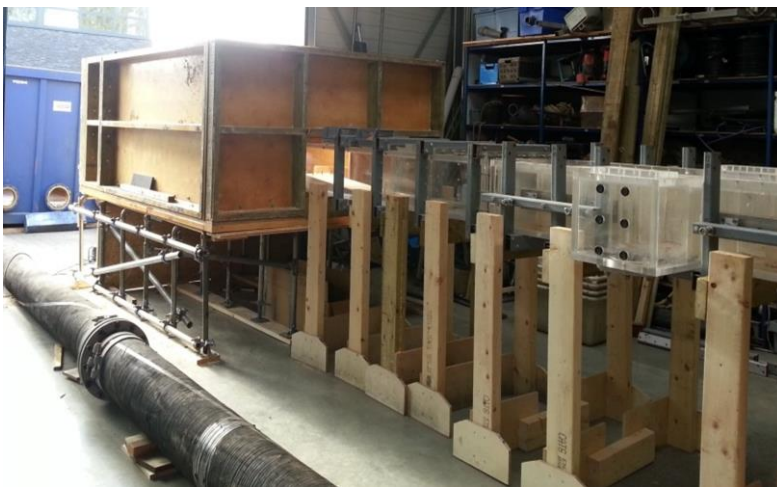
**Fig 2b:** Sink Tank, showing connection to the Reservoir and the VETT device.

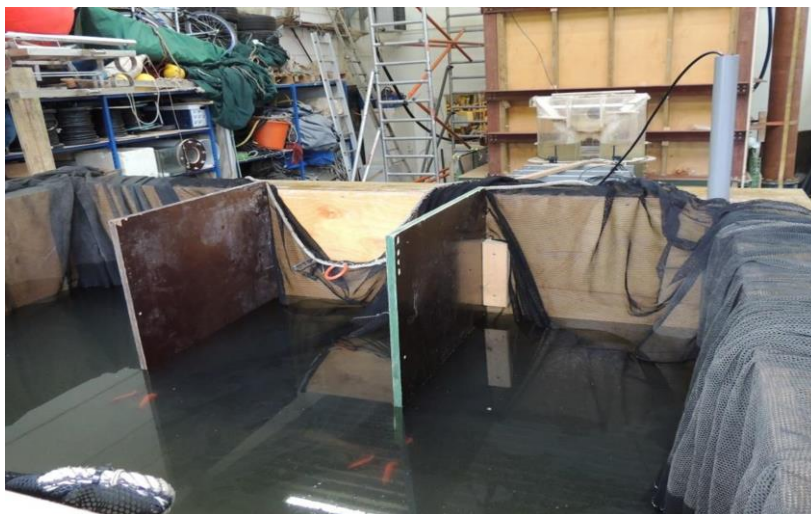
**Fig 2c:** Sink Tank, showing capture netting and internal baffle structures to provide calm areas for fish to rest in after passage through the VETT.

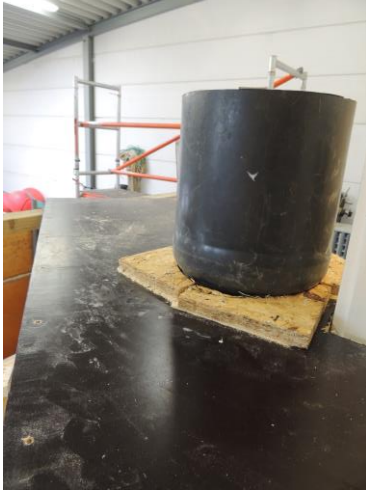
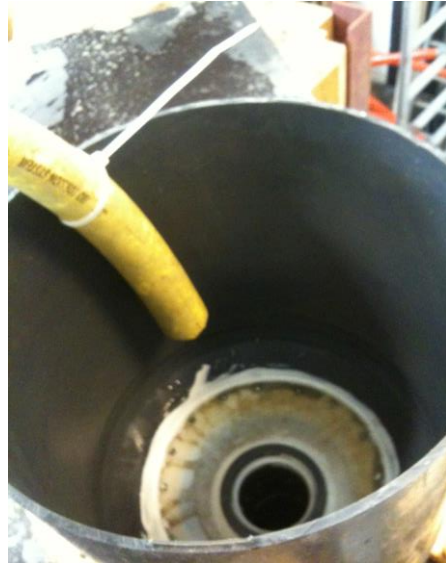
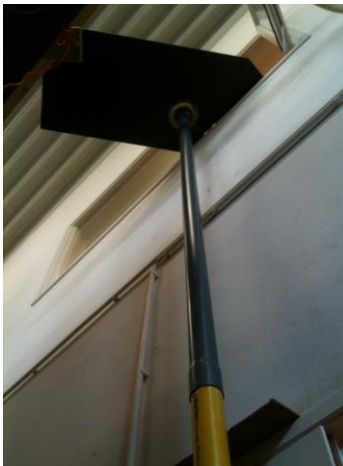
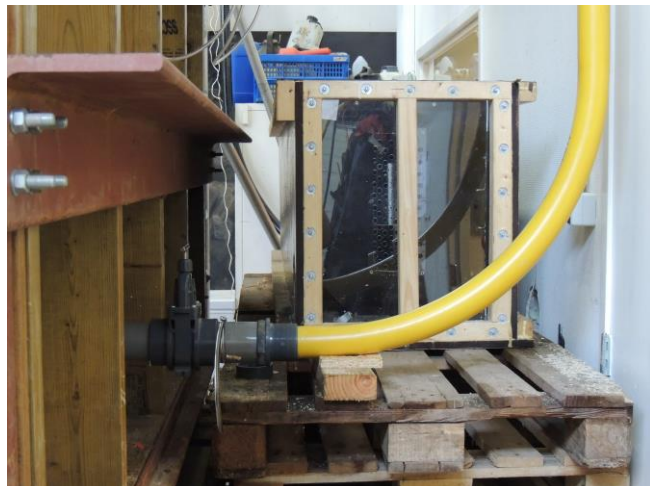
**Fig 2d:** Holding Tank and Entry Port for fish entering the VETT Apparatus

Fish were held in an elevated holding tank (top left), with constant fresh water flow (top right), a gravity fed process (above left and above right) allowed a controlled entry of the fish into the VETT apparatus via an open/closing mechanism on the entry pipe (right)

As indicated in Fig 2d, the fish were placed into an elevated holding tank prior to being introduced into the VETT. This mechanism introduced (via an open/closed valve) the fish through a connecting pipe which opened out into the VETT close to the point of entry of the water coming out of the header tank. A constant flow of water through the gravity-fed pipe system ushered the fish into the pipe and the VETT, as shown in Fig 4a and 4b

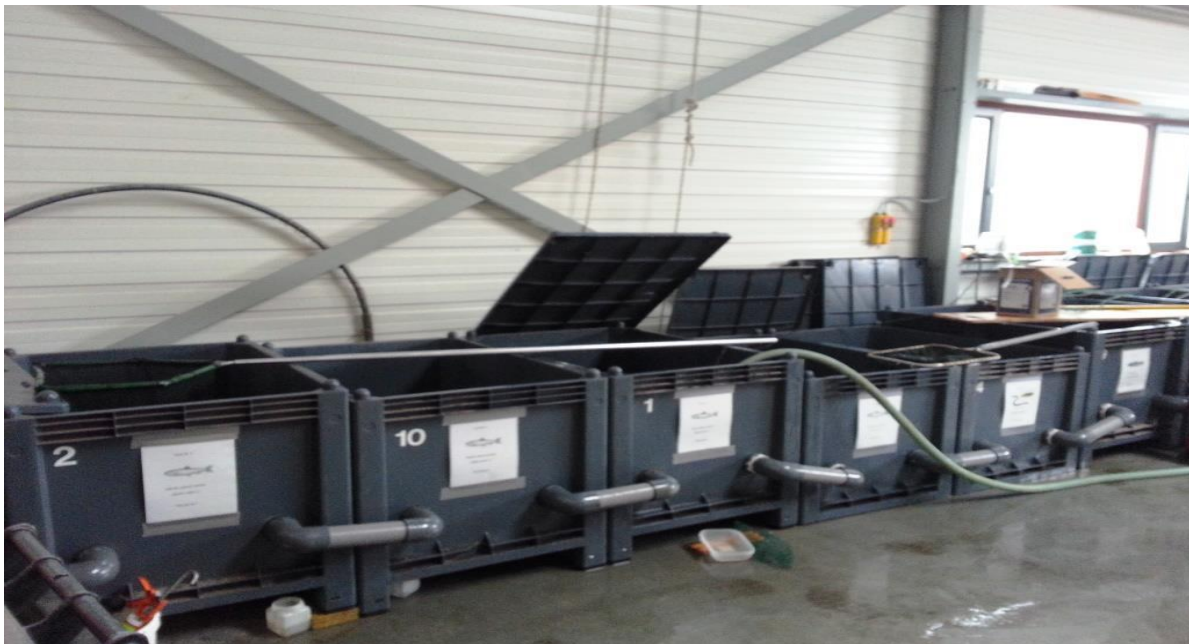
**Fig 3a:** Test fish storage tanks at VisAdvies, showing individual holding/observation tanks for each test group during the trial.

system and develop a uniform pattern of flow. After each run, the pump was turned off as soon as possible, to prevent any incidental damage to the fish which were in the sink tank. After each run, the fish were removed from the sink tank by staff using catch nets and the placed into storage tanks (Fig 3 below) for observation during 72 hours.

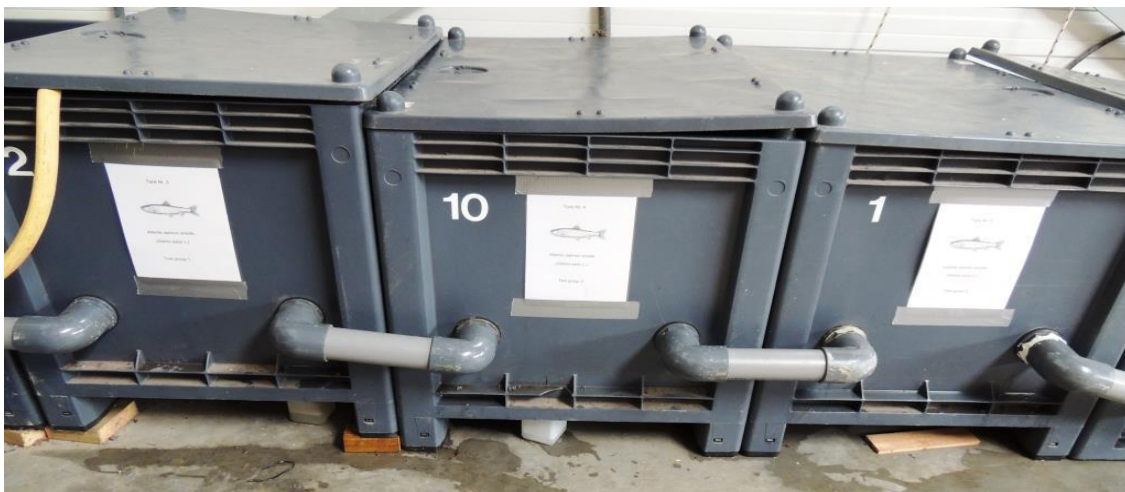
**Fig 3b:** Test fish storage tanks at VisAdvies, showing the circulation water system which supplied fresh, aerated water to the system during the trial.

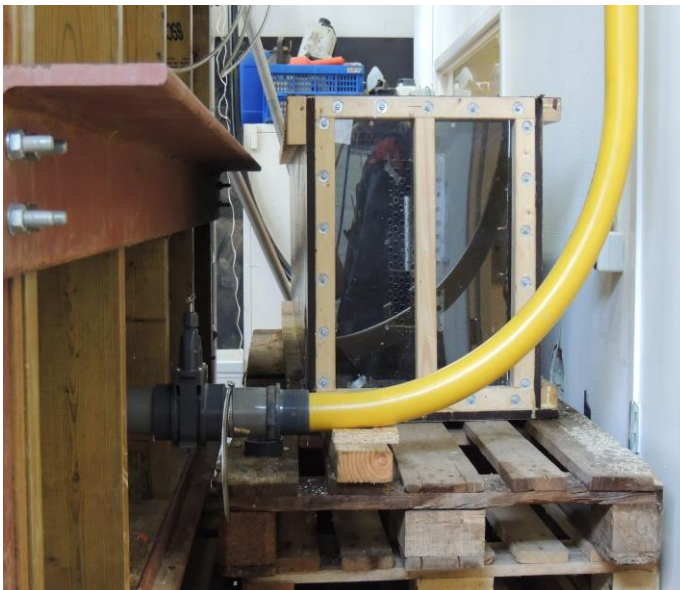
**Fig 4a (left):** Fish entry mechanism to allow the controlled entry of test fish into the VETT apparatus.

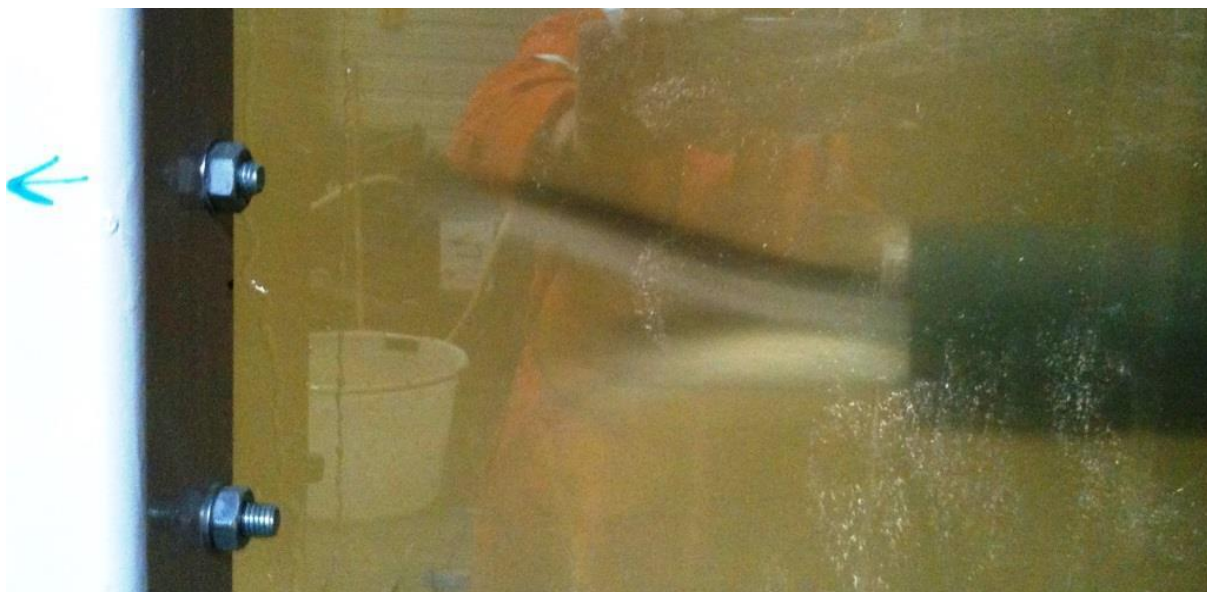
**Fig 4b (below):** Illustrating the entry of fish into the VETT apparatus

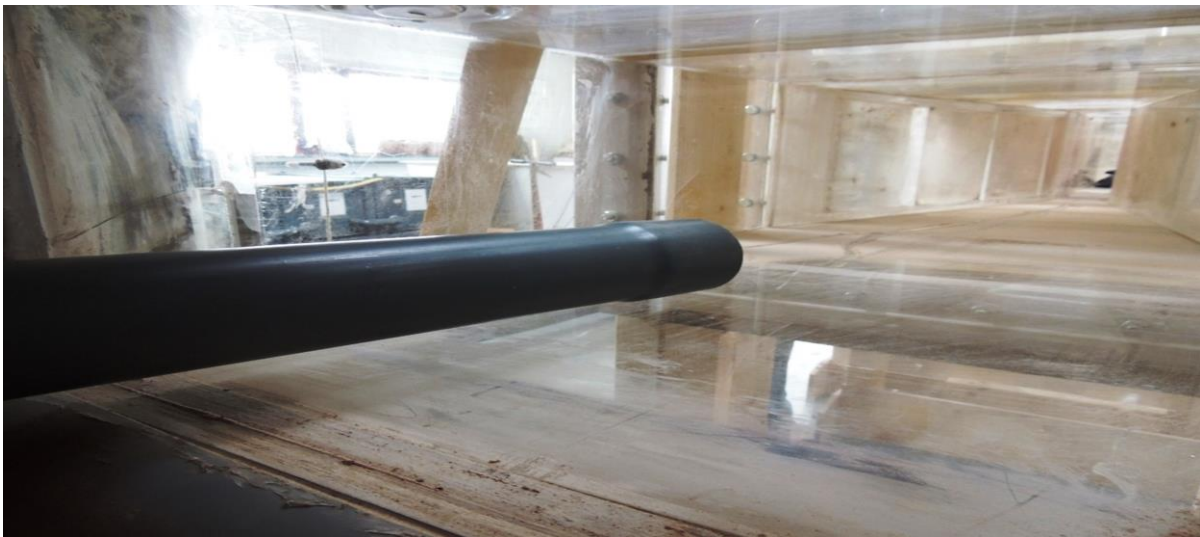
**Fig 5a (above):** Entry pipe running from acclimatisation tank, which introduces the test fish into the VETT apparatus.

To minimise the chances of fish coming out of the acclimatisation tank and being caught/swimming around in the header tank, the connecting pipe from the acclimatisation tank passed through the header tank and its exit was in the entrance of the Perspex culvert section of the VETT apparatus, as shown in Fig 5. This was done to ensure that the fish were introduced in such a way that they could swim as naturally as possible into the VETT apparatus and to minimise any potential for damage they may experience being released directly into the header tank.

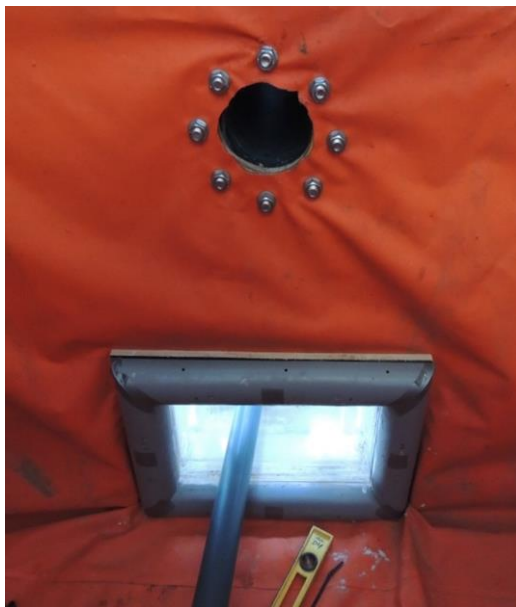
**Fig 5b (Left):** Illustrating the passage of the entry tube, through the body of the header tank and into the mouth of the VETT apparatus

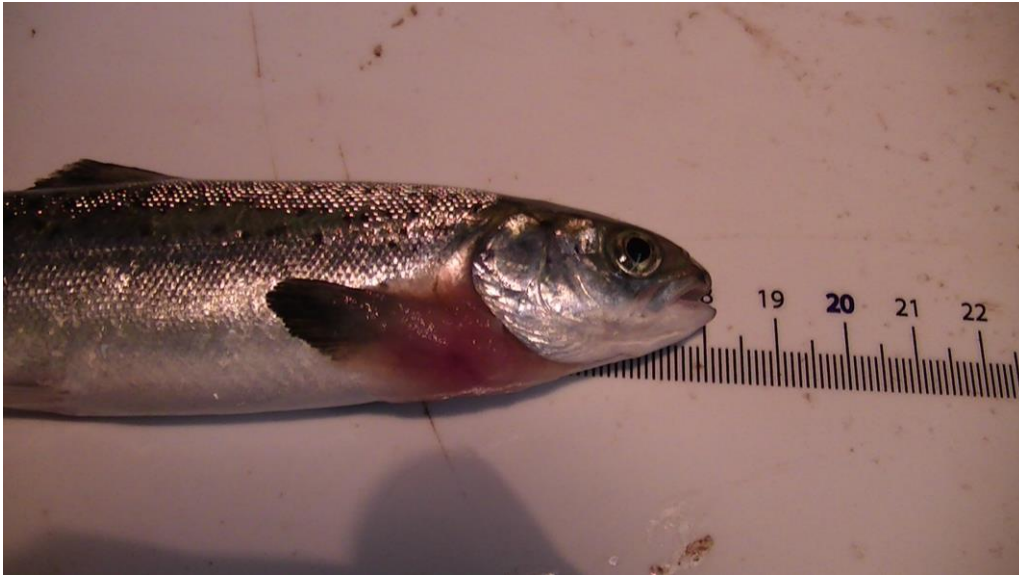
All these fish showed signs of a fungal infection (non-specified species), especially on their fins (as shown in Fig 6).

**Fig 6:** Salmon smolt shown development of fungal infection around fins/gills during post-testing observation period.

Two of the fish which succumbed to fungal infection were from the control group and as such, the deaths were not considered to be due to the testing process or the passage through the VETT apparatus, but purely as a result of the infection itself.

Upon first observations of the fungal infection being recorded, approximately 20hrs into the 72hr post-testing observation, a small concentration of salt was introduced into the water and recirculated for 4 hours. At this point, the water was refreshed with clean, salt-free water. No further incidences of fungal infections were recorded.

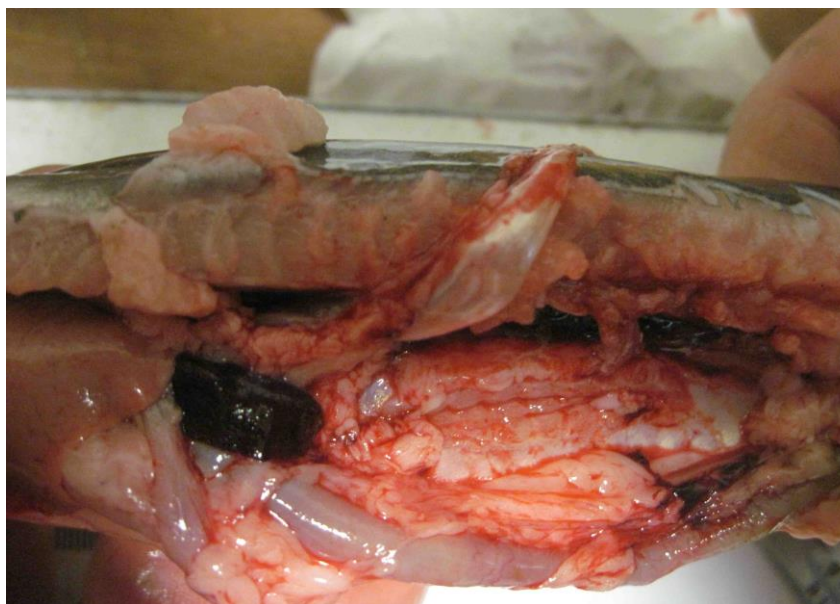
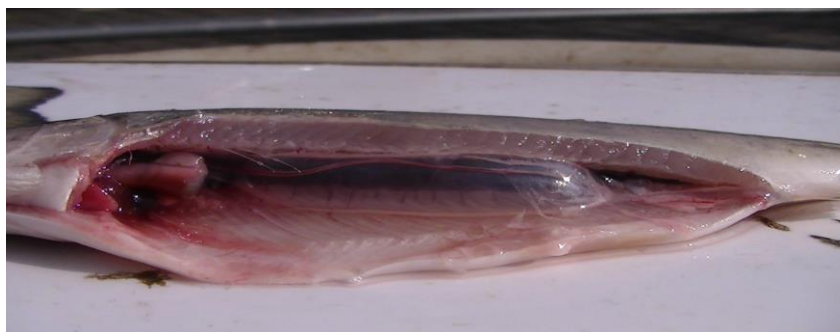
During the autopsy process for each of the above, no physical damage or anatomical anomalies were recorded in the individuals examined, swim bladders were intact and there were no visible internal haemorrhages recorded, nor were there any physical signs of bubbles in the eyes (as shown in Figure 8).

**Figure 8:** Example autopsies showing undamaged susceptible internal organs and structures in test animals 72hrs after passing through the VETT apparatus
